7034

Camshaft Drive Chain Wear Indicator BMW/Mini

Instructions

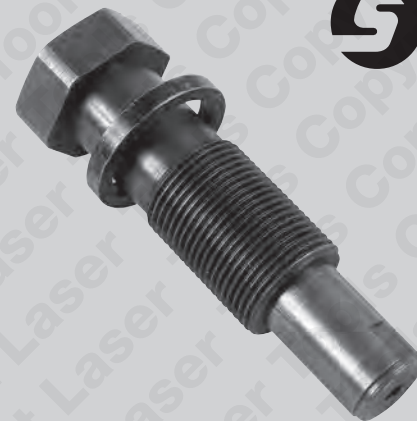
The Camshaft Drive Chain Wear Indicator is designed to check the timing chain stretch on the BMW Mini petrol engines listed without dismantling the engine.

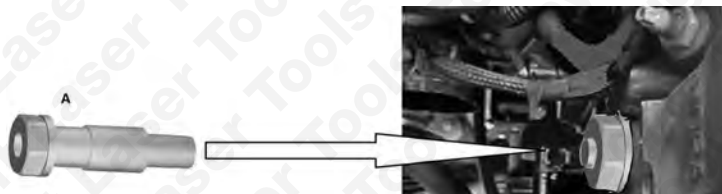
2. Screw in component A complete with the spacer ring as shown. Fig:2
